**Summary of Geotechnical Investigation and
Pit Slope Stability Assessment
Maria Pit Expansion**

October 2015

CS Mining
PO Box 608
1208 South 200 West
Milford, Utah 84751

Cardno, Inc.
534 Bluefield Industrial Park
Bluefield, Virginia 24605
www.cardno.com

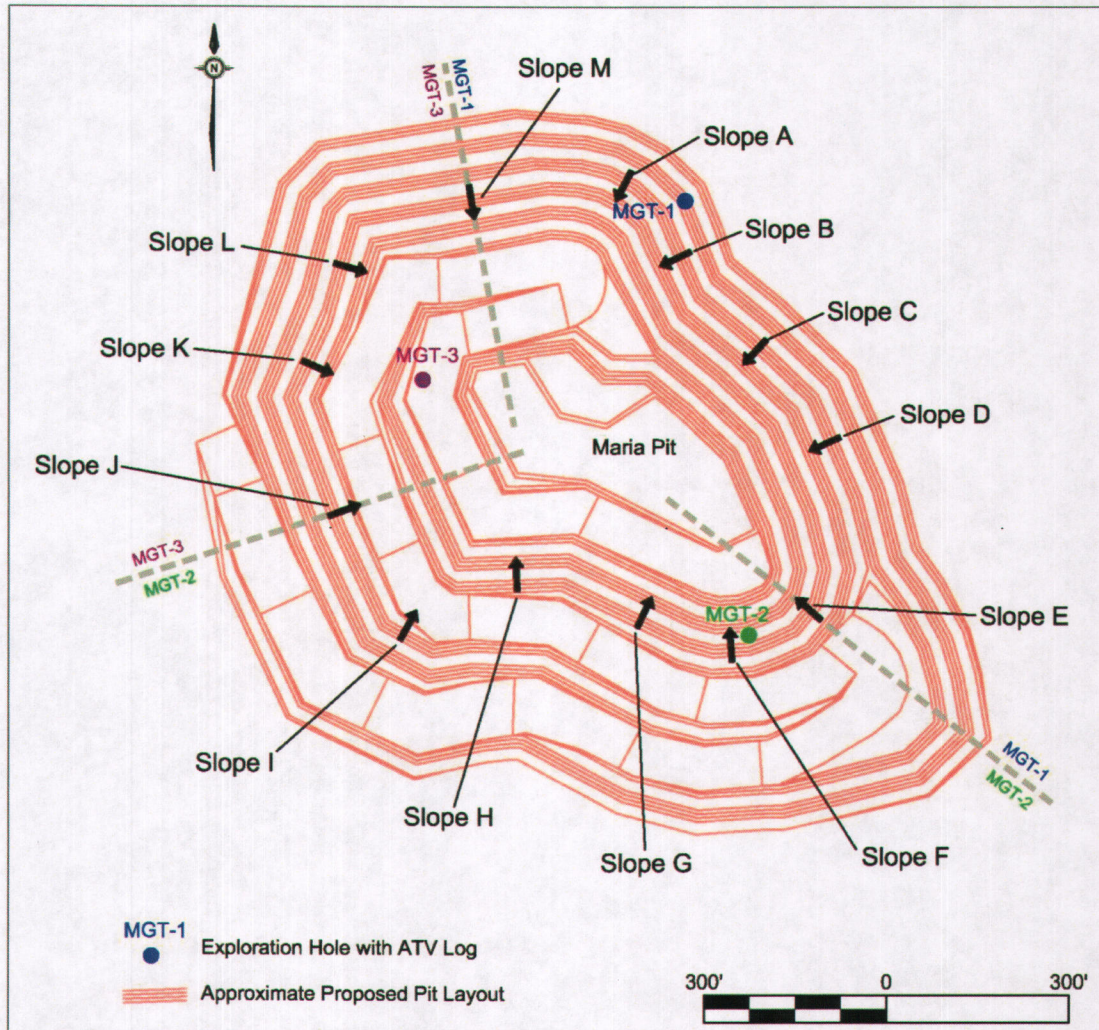
Figure 3-3: Delineation of Projected Pit Wall Areas (Design Sector Layout)

The following statements summarize the results of the kinematic stability assessment. *Figure 3-3* shows the locations of the discrete slopes analyzed and the corresponding geologic data.

- > The east wall of the proposed pit (Slopes A through D) is expected to have the greatest potential for planar and wedge failures. Planar failures located in the east wall are associated with two different joint sets. Nearly all the potential wedge failures in the eastern wall are associated with joint combinations containing a high-angle joint set that is very abundant in the existing pit walls. Wedge failures in the east wall are generally expected to be approximately 10 tons or less. Distribution of discontinuity sets in the east wall is shown by the stereonet in *Figure 3-4*.

- > Potential planar failure exists in Slopes K and L in the northwestern portion of the proposed pit due to the presence of a single joint set. In addition, wedges with high probability of failure exist within Slopes J, K, and L. The wedges are generally expected to be 10 tons or less. Distribution of discontinuity sets in the northwest wall is shown by the stereonet in *Figure 3-5*.

- > No significant planar wedge failures are expected in the southwestern portion of the proposed pit (Slopes F through I).
